Commercial Grade

CARBON FIBER BOWING WALL STABILIZATION

SRS 600UNI
CARBON FIBER

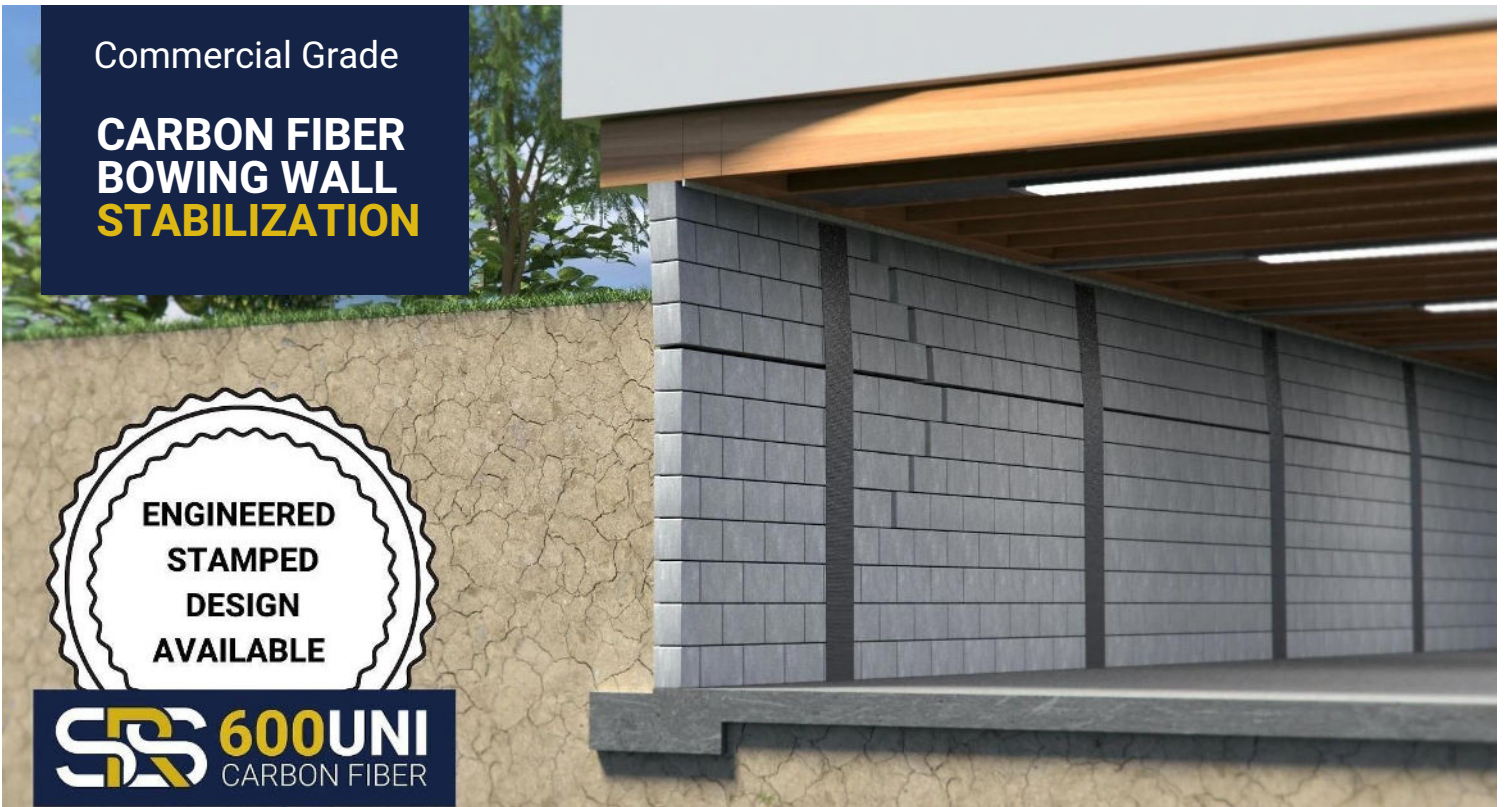
The SRS Commercial Grade Carbon Fiber Composite Straps permanently secure and stabilize the basement wall against any further inward movement.

Each composite strap exhibits a design tensile strength of almost 40,000 lbs to permanently stop inward movement related to the external soil pressure.

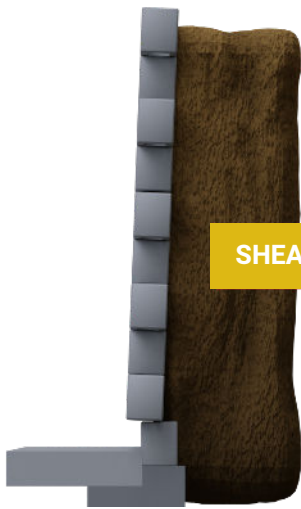
SHEARING

Block or CMU walls fail for a number of reasons from lack of reinforcing steel to excessive loads due to expansive soils or excess ground water. Even with the appropriate amounts of reinforcing steel in place, where the walls are constructed properly, expansive clay soils can still cause bowing if the cores are not fully grouted.

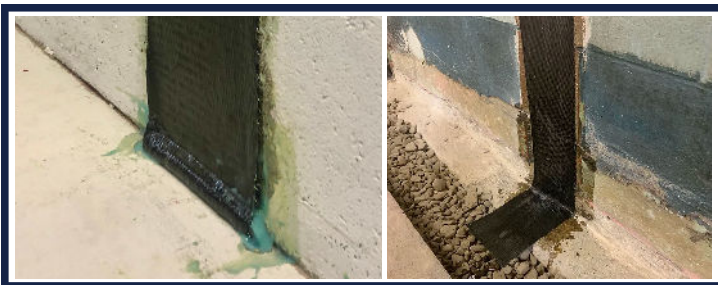
When shearing at the base is a concern, Carbon Fiber anti shearing bottom anchors can be tied in below the slab and into the foundation to keep the wall from sliding.

In cases where an interior drainage system is being installed, these straps can be securely anchored to the footer before the floor is re-poured.

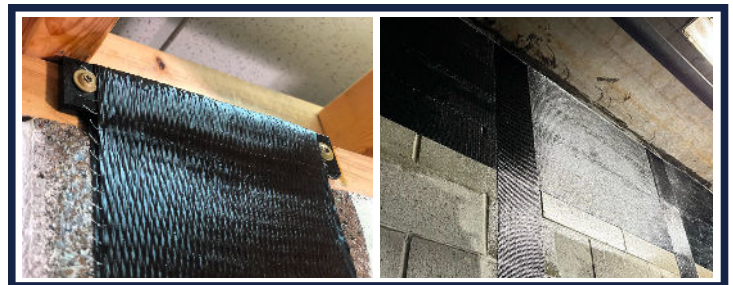
In cases where the bow/opened mortar joints are high on the wall, the SRS-660 Bidirectional Carbon Fiber can be used to provide increased bond strengths on the ends of the straps as well as localized crack repair on the opened joint.

In cases where additional anchorage needs to be provided or if the wall is exhibiting signs of tipping, top connections connecting the bowed wall straps to the house framing can be added.
